2011

**Safety Performance Report on
Victorian Electricity Distribution
and Transmission Businesses**

Report released 31 August, 2012

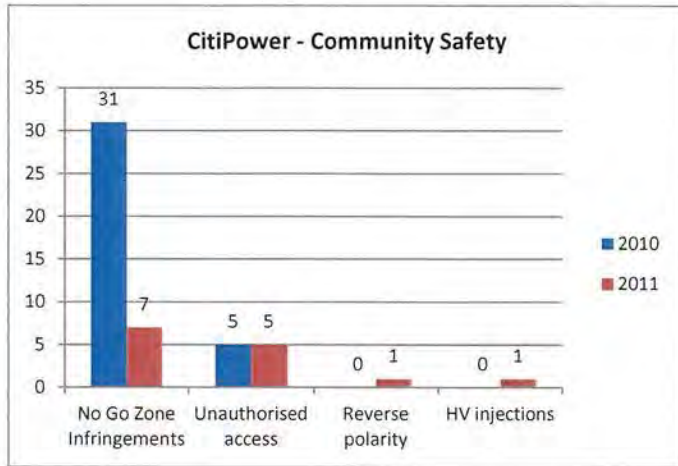
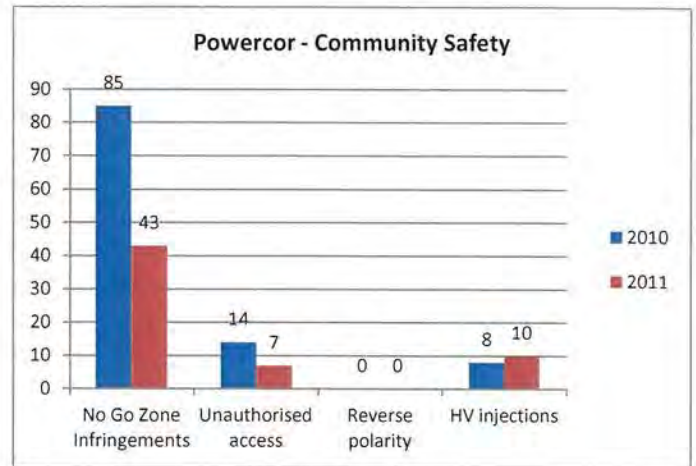
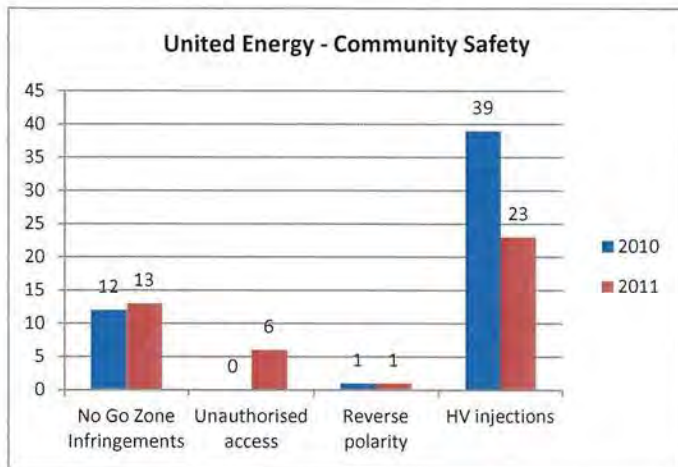
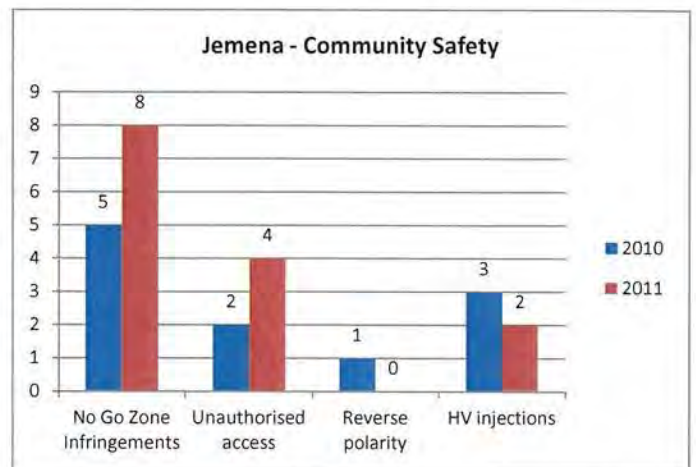
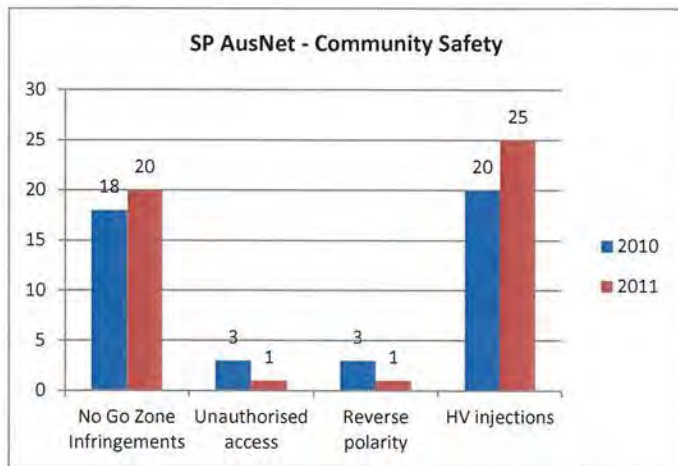
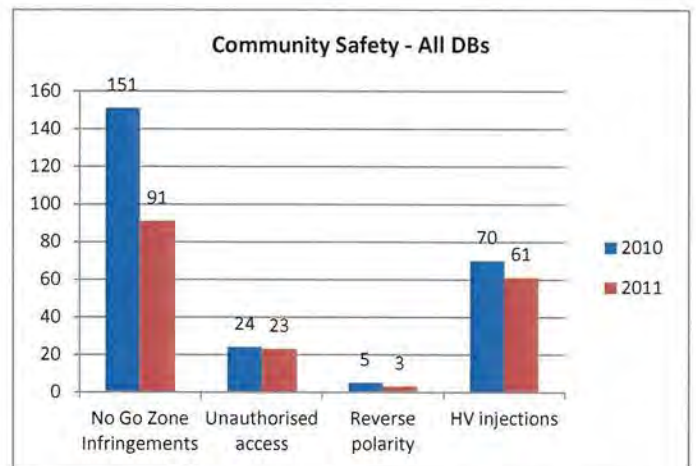
Figure 4 Safety incidents involving the public by business

(The 2010 safety performance report had an incorrect quantity for NGZ infringements for SP AusNet which has been corrected in the graph above)

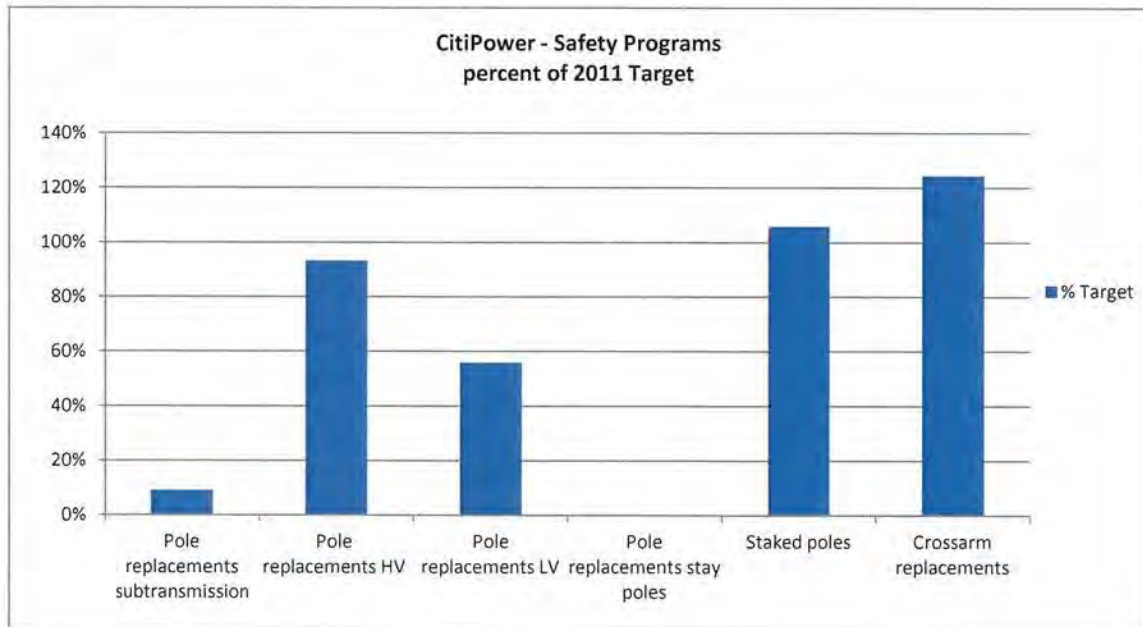
Figure 6 CitiPower Safety Programs – per cent of 2011 target

Note: Overhead conductor replacement program not shown in graph above as data is not available
